ANNUAL REPORT FOR 2015

UT to Muddy Creek Mitigation Site
Randolph County
TIP No. R-2606WM
COE Action ID: SAW-2004-00340
NCDWR #: 2006-0331

Prepared By:
Natural Environment Section & Roadside Environmental Unit
North Carolina Department of Transportation
July 2015

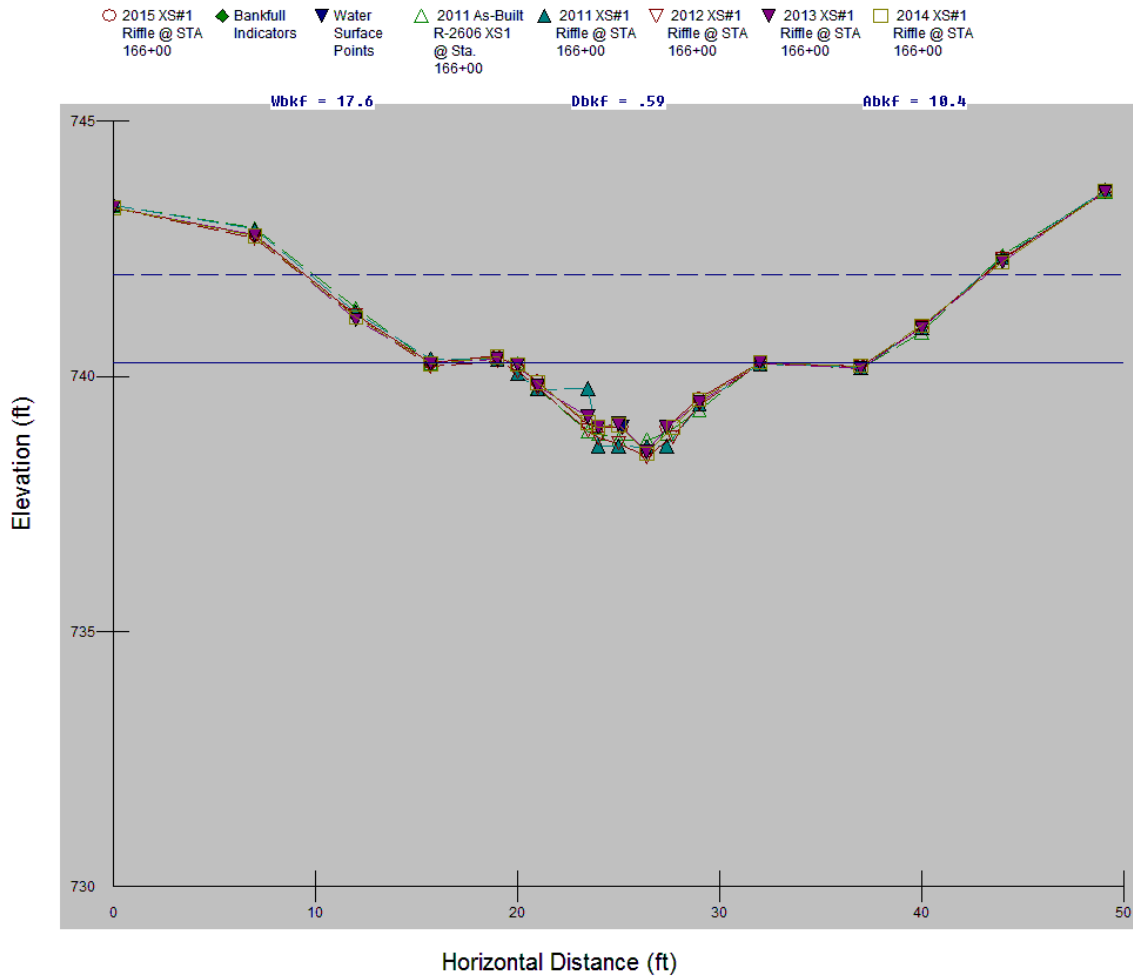
R-2606 XS#1 @ STA 166+00

Based on comparisons of the monitoring data to the as-built data, all seven cross sections appear stable with little or no active bank erosion. Graphs of the cross sections are presented in Appendix A. Future survey data will vary depending on actual location of rod placement and alignment; however this information should remain similar in appearance.

Cross-Section #1 (Riffle) Abbreviated Morphological Summary					
	2011	2012	2013	2014	2015
Bankfull Width (ft.)	12.71	12.75	12.3	12.27	12.36
Bankfull Mean Depth (ft.)	0.85	0.94	0.84	0.86	0.83
Width/Depth Ratio	14.95	13.56	14.64	14.27	14.89
Bankfull Cross Sectional Area (ft ²)	10.84	11.93	10.31	10.6	10.21
Maximum Bankfull Depth (ft.)	1.63	1.82	1.75	1.79	1.74
Width of the Floodprone Area (ft.)	32.59	34.21	34.03	34.3	33.59
Entrenchment Ratio	2.56	2.68	2.77	2.8	2.72

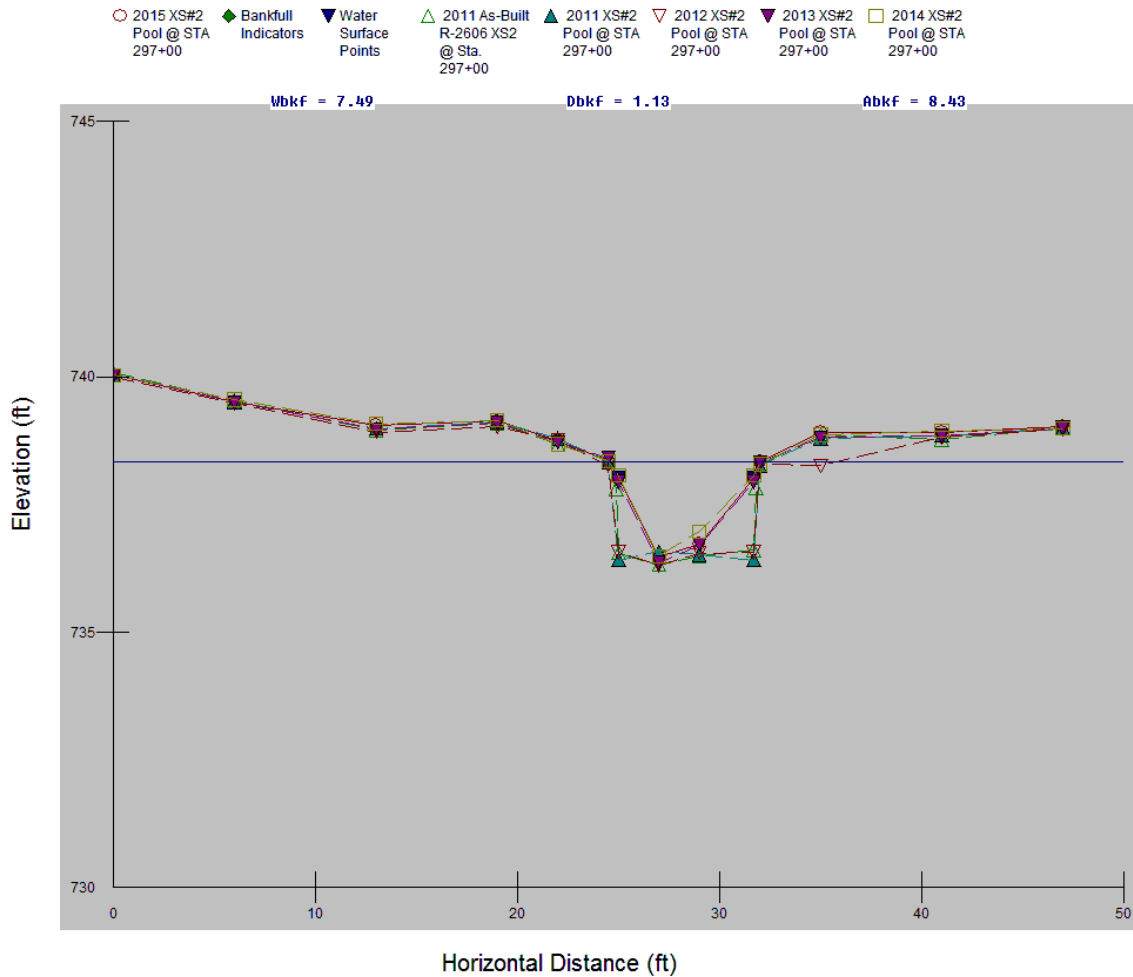
R-2606 XS#2 Pool @ STA 297+00

Cross-Section #2 (Pool) Abbreviated Morphological Summary*					
	2011	2012	2013	2014	2015
Bankfull Cross Sectional Area (ft ²)	17.95	12.52	8.66	7.3	8.43
Maximum Bankfull Depth (ft.)	2.39	1.98	1.95	1.8	1.87
Bankfull Mean Depth (ft.)	1.38	1.15	1.17	0.99	1.13
Bankfull Width (ft.)	13	10.93	7.39	7.39	7.49

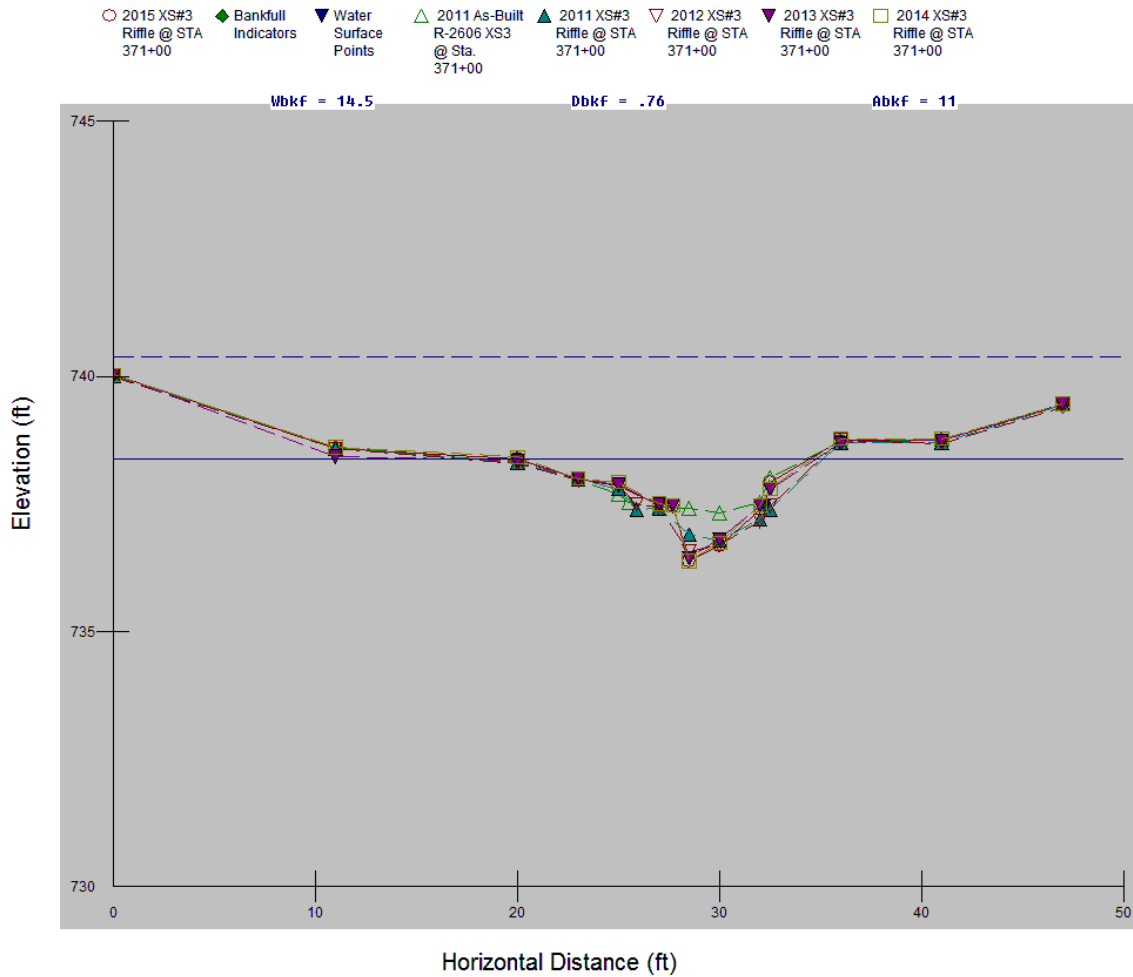
R-2606 XS#3 Riffle @ STA 371+00

Cross-Section #3 (Riffle) Abbreviated Morphological Summary					
	2011	2012	2013	2014	2015
Bankfull Width (ft.)	14.94	14.76	14.65	14.71	14.46
Bankfull Mean Depth (ft.)	0.75	0.77	0.71	0.77	0.76
Width/Depth Ratio	19.92	19.17	20.63	19.1	19.03
Bankfull Cross Sectional Area (ft ²)	11.18	11.38	10.37	11.29	11.02
Maximum Bankfull Depth (ft.)	1.53	1.73	1.91	2.04	2
Width of the Floodprone Area (ft.)	45.62	47	47	47	47
Entrenchment Ratio	3.05	3.18	3.21	3.19	3.25

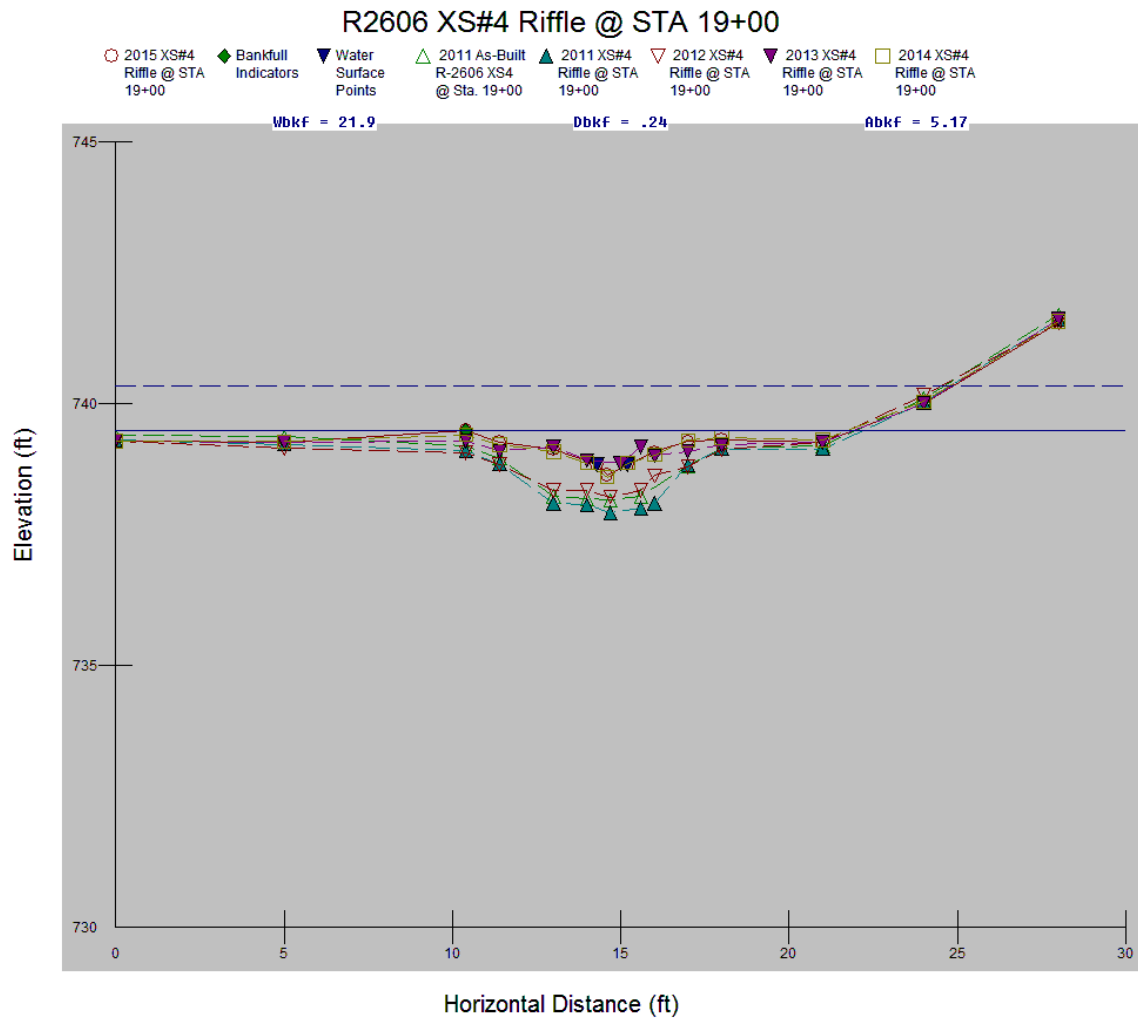
Cross-Section #4 (Riffle) Abbreviated Morphological Summary					
	2011	2012	2013	2014	2015
Bankfull Width (ft.)	8.95	7.39	10.68	10.6	11.49
Bankfull Mean Depth (ft.)	0.61	0.47	0.17	0.25	0.31
Width/Depth Ratio	14.67	15.72	62.82	42.4	37.06
Bankfull Cross Sectional Area (ft ²)	5.42	3.48	1.76	2.66	3.53
Maximum Bankfull Depth (ft.)	1.22	0.84	0.43	0.81	0.85
Width of the Floodprone Area (ft.)	24.84	23.11	22.82	24.47	24.86
Entrenchment Ratio	3.05	3.13	2.14	2.31	2.16

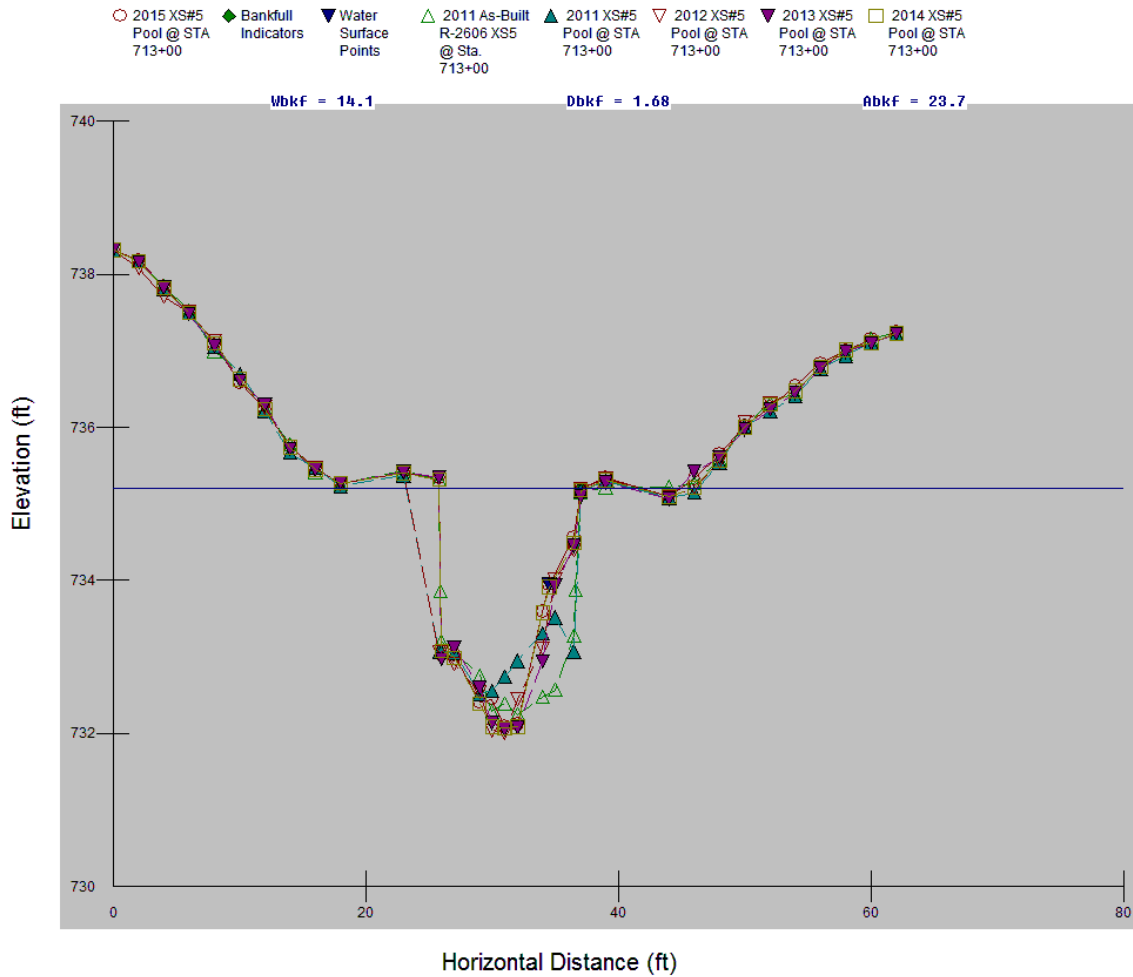
R-2606 XS#5 Pool @ STA 713+00

Cross-Section #5 (Pool) Abbreviated Morphological Summary*					
	2011	2012	2013	2014	2015
Bankfull Cross Sectional Area (ft ²)	26.83	27.78	23.86	24.12	23.72
Maximum Bankfull Depth (ft.)	2.65	3.19	3.04	3.11	3.11
Bankfull Mean Depth (ft.)	1.5	1.55	1.98	1.66	1.68
Bankfull Width (ft.)	17.9	17.87	12.07	14.55	14.14

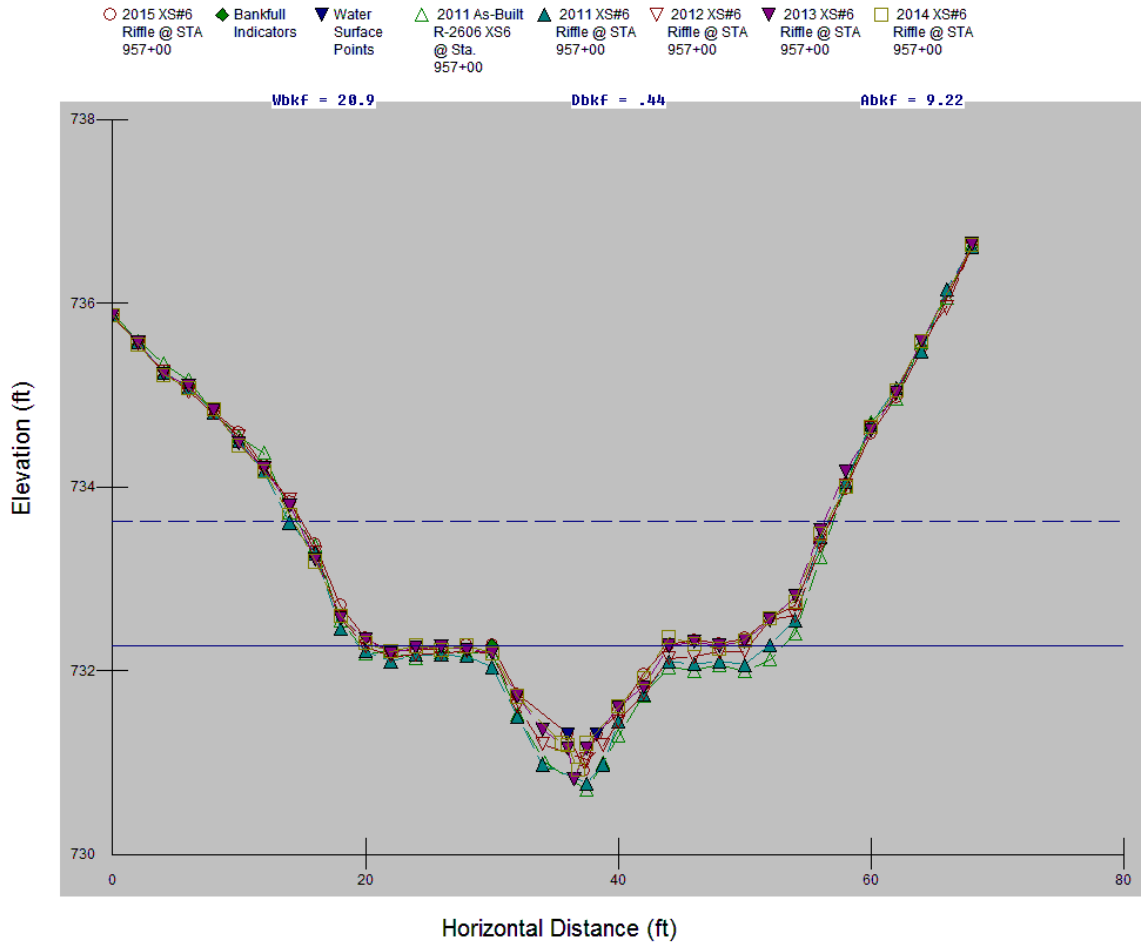
R-2606 XS#6 Riffle @ STA 957+00

Cross-Section #6 (Riffle) Abbreviated Morphological Summary					
	2011	2012	2013	2014	2015
Bankfull Width (ft.)	15	13.79	14	13.23	13.94
Bankfull Mean Depth (ft.)	0.71	0.67	0.7	0.62	0.64
Width/Depth Ratio	21.13	20.58	20	21.34	21.78
Bankfull Cross Sectional Area (ft ²)	10.72	9.21	9.85	8.16	8.95
Maximum Bankfull Depth (ft.)	1.33	1.1	1.45	1.27	1.36
Width of the Floodprone Area (ft.)	40.86	39.49	42.32	40.98	41.9
Entrenchment Ratio	2.72	2.86	3.02	3.1	3.01

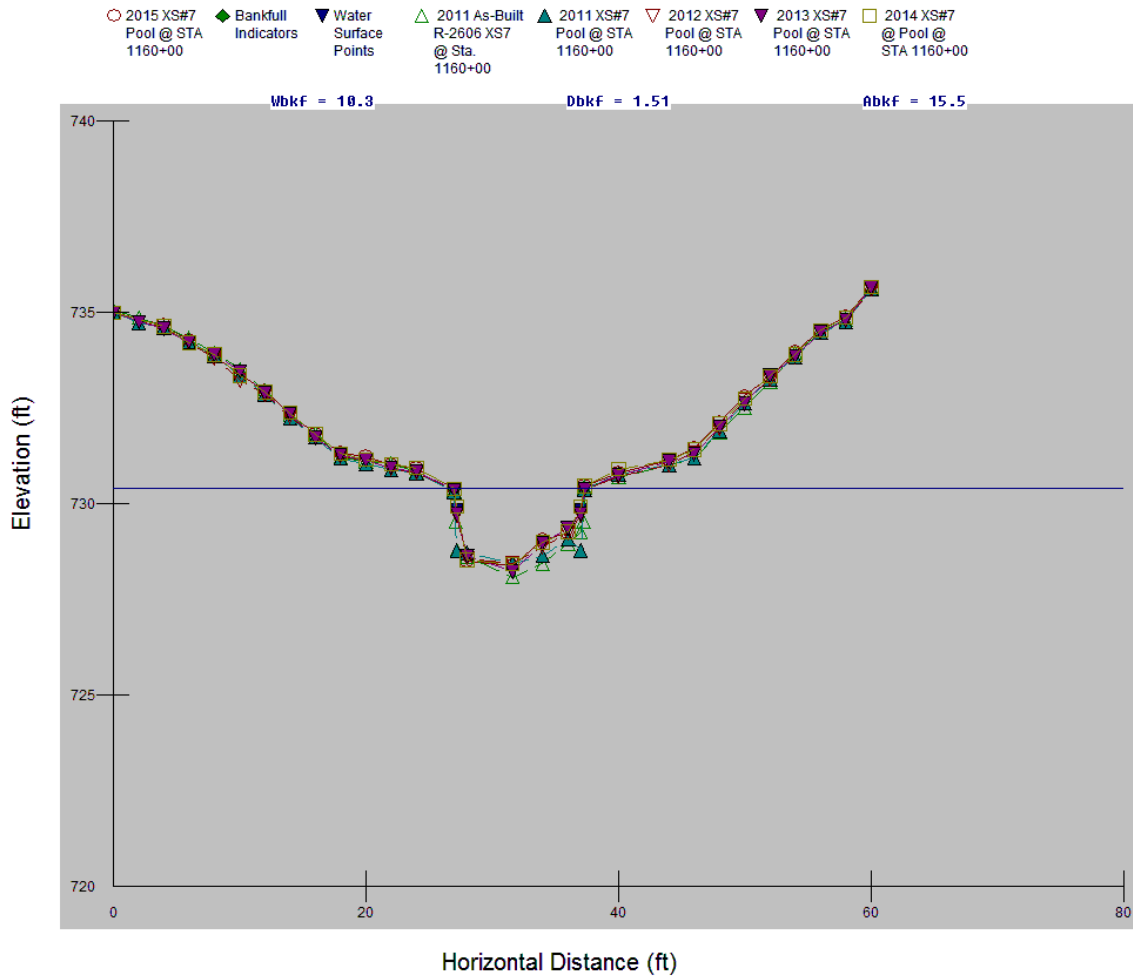
R-2606 XS#7 Pool @ STA 1160+00

Cross-Section #7(Pool) Abbreviated Morphological Summary*					
	2011	2012	2013	2014	2015
Bankfull Cross Sectional Area (ft ²)	16.32	15.44	15.55	15.33	15.5
Maximum Bankfull Depth (ft.)	1.85	1.92	2.14	1.97	2.01
Bankfull Mean Depth (ft.)	1.59	1.5	1.51	1.49	1.51
Bankfull Width (ft.)	10.3	10.3	10.29	10.26	10.27

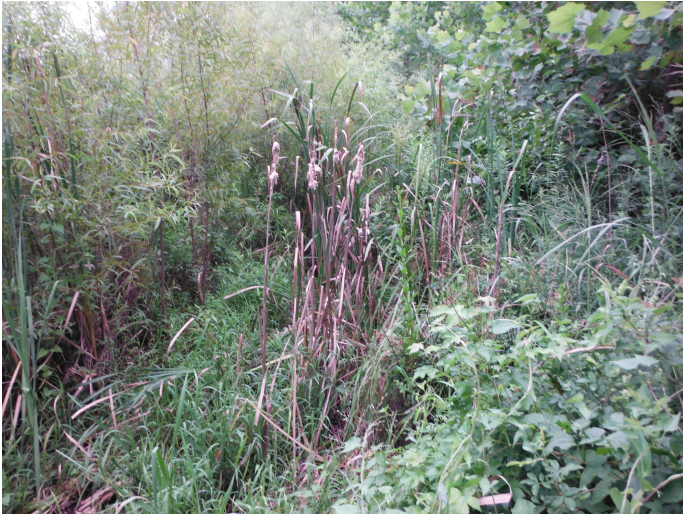
Photo Point #1 (Upstream)

A visual inspection of the channel and photos taken from photo points 1 through 7 showed that the channel bed is stable throughout the stream relocation at this time. Bankfull events have been visually noted by wrack lines on 9/13/12 and 8/26/14.
